Khān al-‘Askar Rehabilitation Project

Report
April 2013

JESCO Contracting Trading & Enterprising

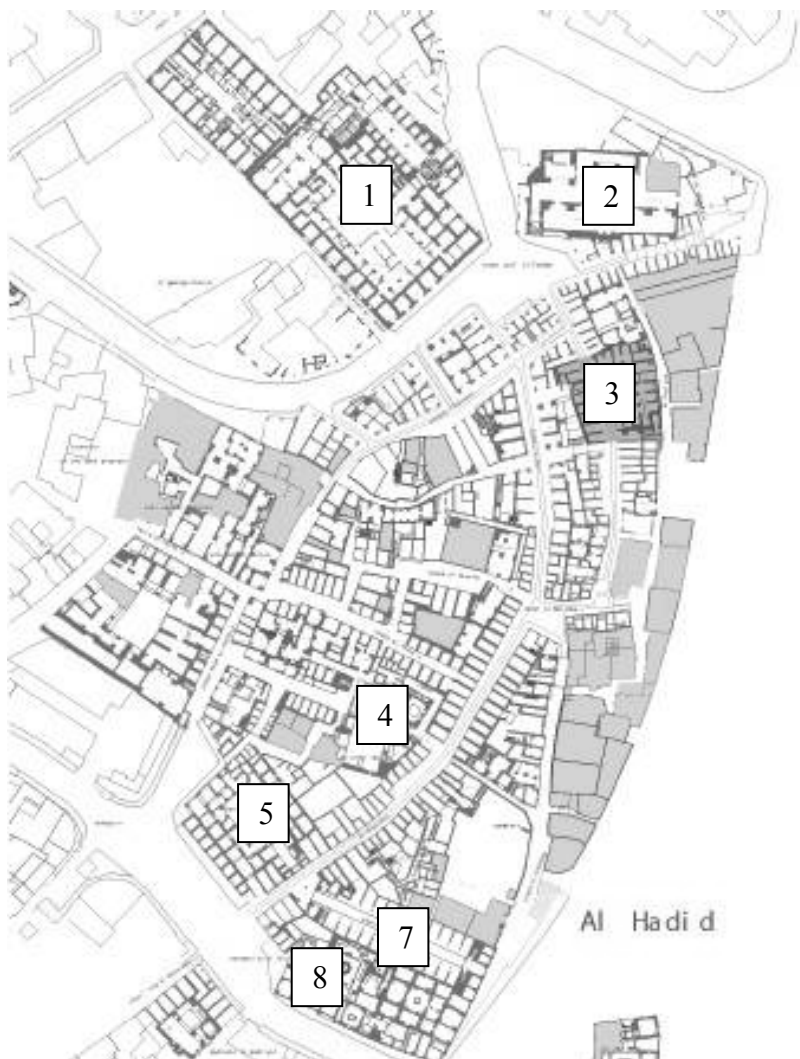
fig. Plan of the north-wetsern quarter , OIB 2004 (not to scale) 1. Khan al askar, 2.Tawba, 3. Suq Haraj, 4. Attar Mosque, 5.Khan al Masryin, 6.Khan al Khayyatin and Hammam Izz an Din

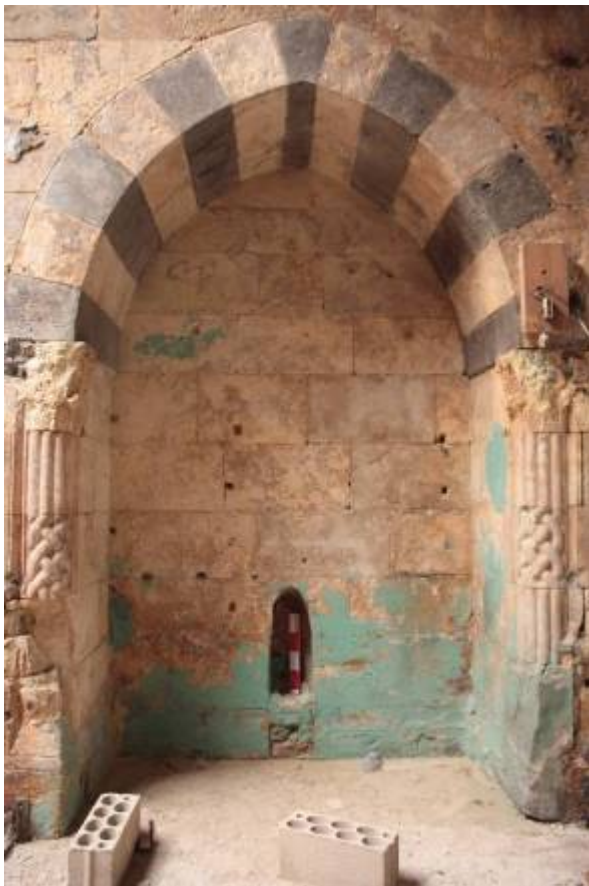
Although military and therefore functional in general aspect, the Khan al Askar nonetheless has three decorative elements on its ground floor. An alcove to the right of the entrance to the larger unit is decorated with two engaged braided colonnettes. Braided columns flanking a central element was a popular scheme for the decoration of khans in Aleppo, as, for example, on the facades of Khan Uzdampur, Khan al Sabun, and Khan al Wazir.¹³

Khan A fountain

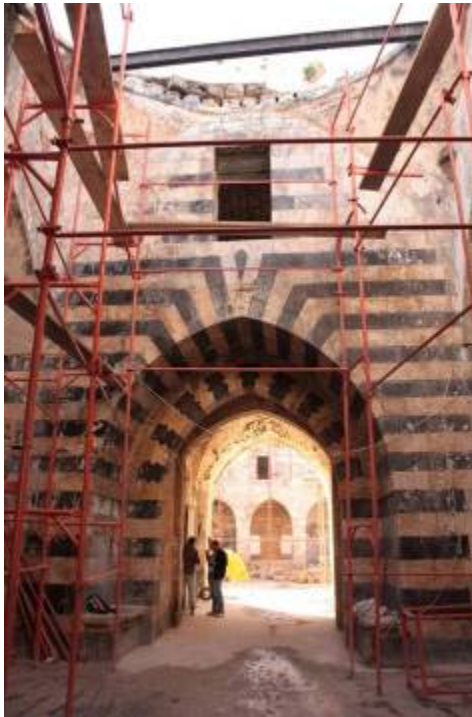
Two other decorative elements are set around arches. The first, set on the inner side of the entrance of the connecting vaulted corridor, is a framing band of Tripoli fish scale, with each of the units or "scales" containing a fan-like stylized leaf in both its lower and upper part. The area between this repeat and the arch above is filled with the same stylized fan-like leaves opening vertically toward the top.¹⁴

Khan A entrance during restoration

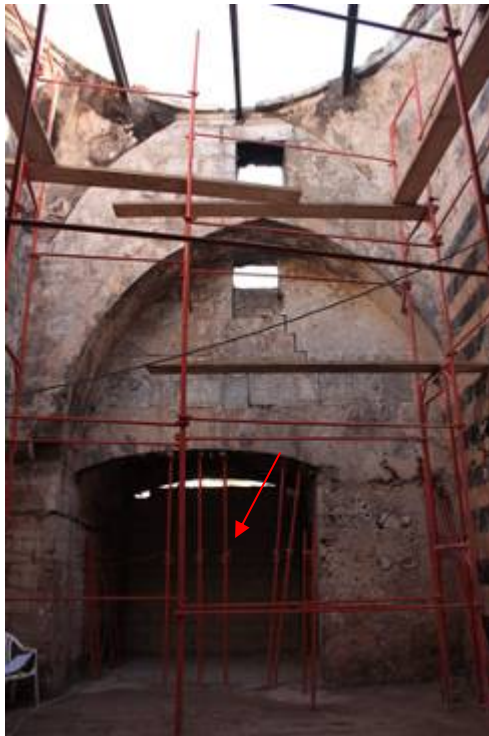
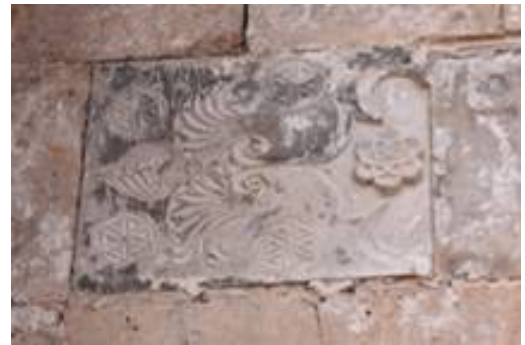
[DETAIL D1 1/5]

The second gate that is flanked from exterior wall with the ottoman toghra, has a decorative marble motif on its interior lintel

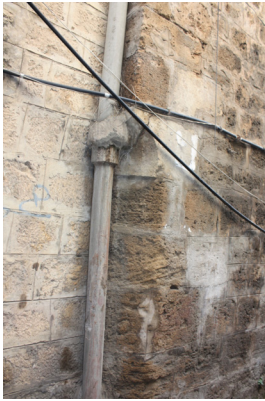
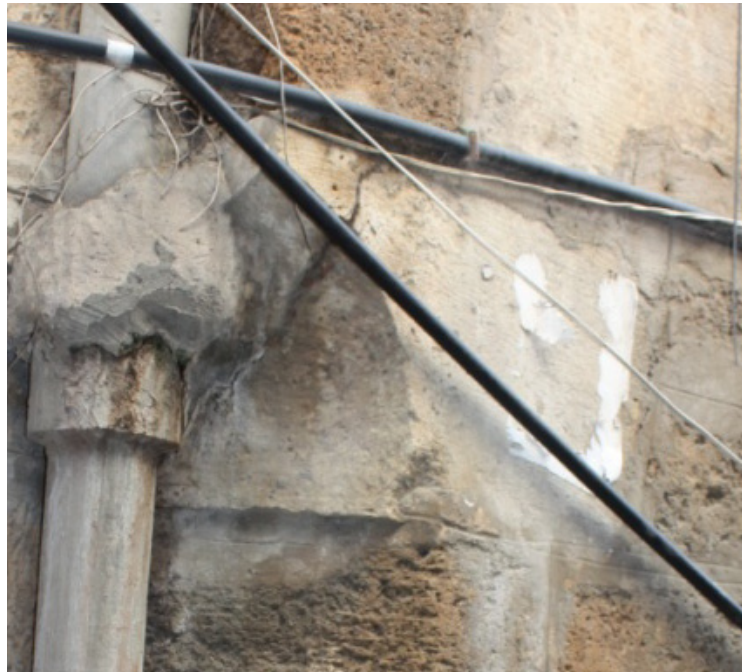
- 3. The muqarnass detail at the intersection gives an evidence that khan A was built prior to khan B.

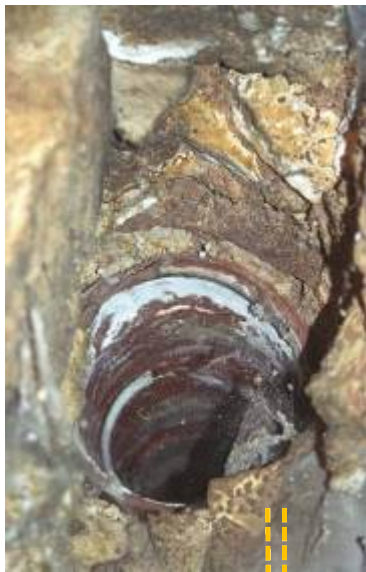
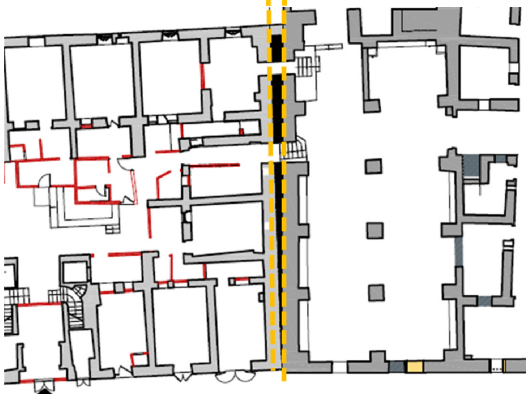
- 4. The canalisation in the filled area between the two khans is an evidence that one of the elevations was an exterior one.

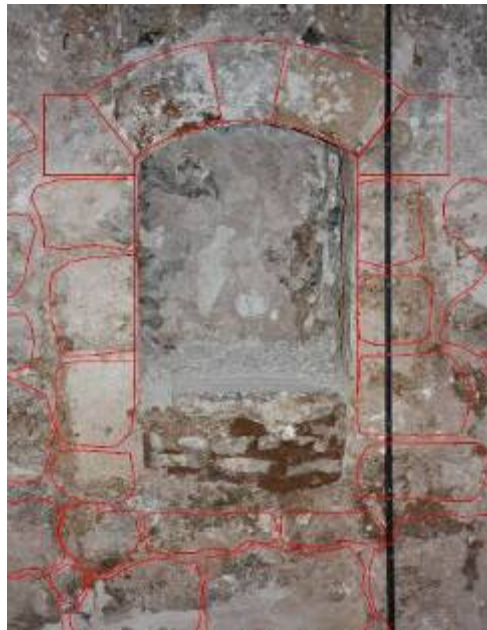
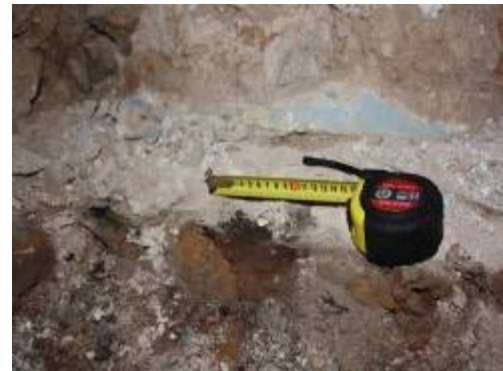
Khan A

Chimneys were found and identified in both khans A and B

They are a major ottoman evidence. Niches that were transformed by the inhabitants into cupboards revealed after removing the additions , vertical conducts; the chimneys conducts.

← The chimney

↑ traces of fire

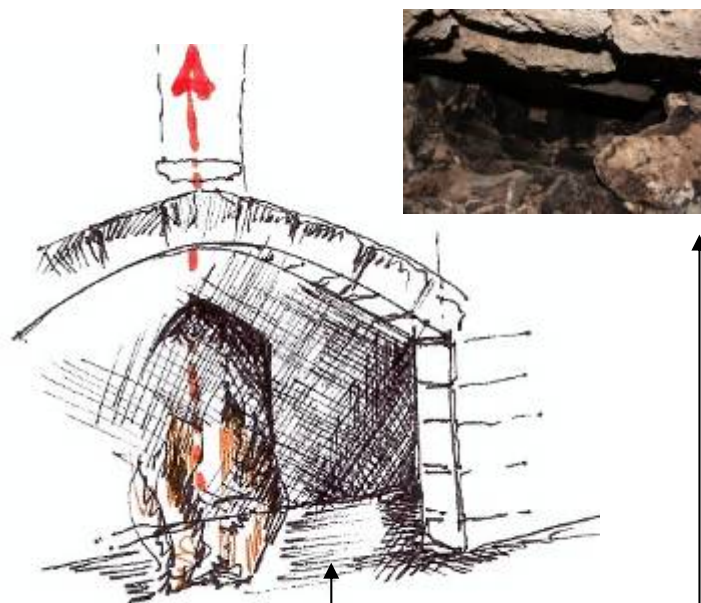
Khan B

↑ Hypothetical restitution

↑ in situ chimney conduct

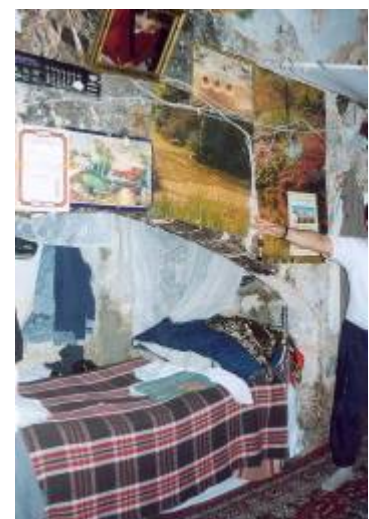
↑ the chimney used as a bed niche

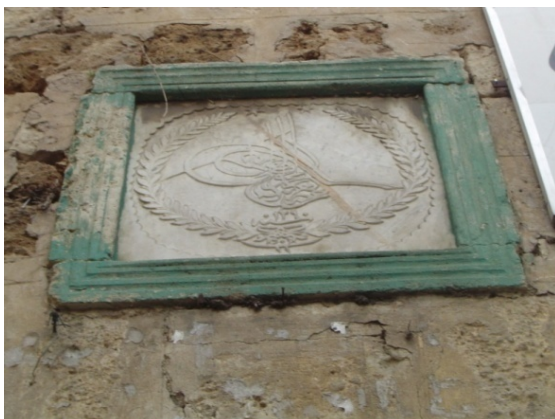
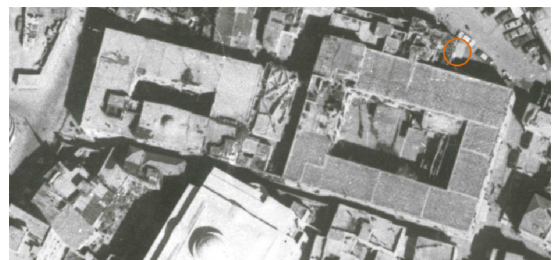
the Imperial monogram *toghra* of the Sultan Abdul Majid, dated 1852: *Terminus ante quem* for this façade installation

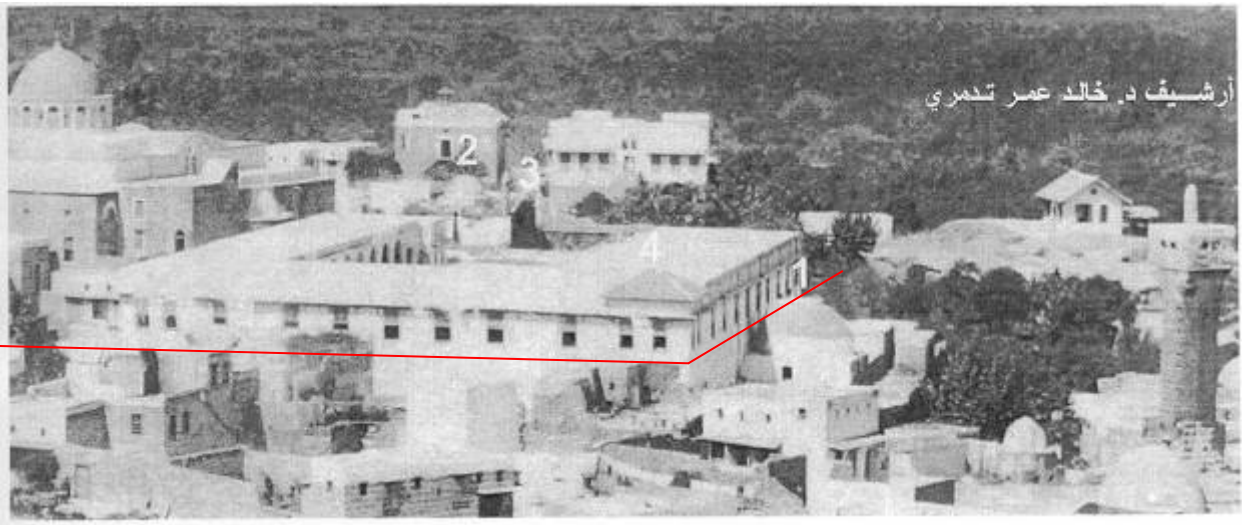
On the other hand, the same picture shows a dome above the souk main entrance. The *pendant* of the dome are still visible. Decision was taken not to reconstruct the dome for both financial and conceptual reasons. Instead, a light wood and glass structure was installed allowing light to enter and keeping the reading of the original structure possible.

The entrance without a dome and a no traces of the 3rd floor
1939 . IFPO

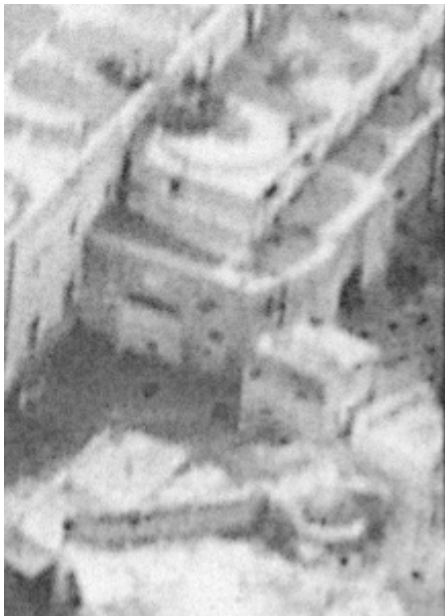
Old picture showed an additional third floor that doesn't exist anymore. When cleaning the roof, traces of stone masonry wall were noticed and they were removed under the supervision of an archeologist who submitted the report at the end of the works.

Old picture showed a dome over the opening. In reference to the international charters, reconstructions aren't recommended it was decided not to reconstruct the dome but instead to install a light wooden glazed structure allowing light and air to enter.

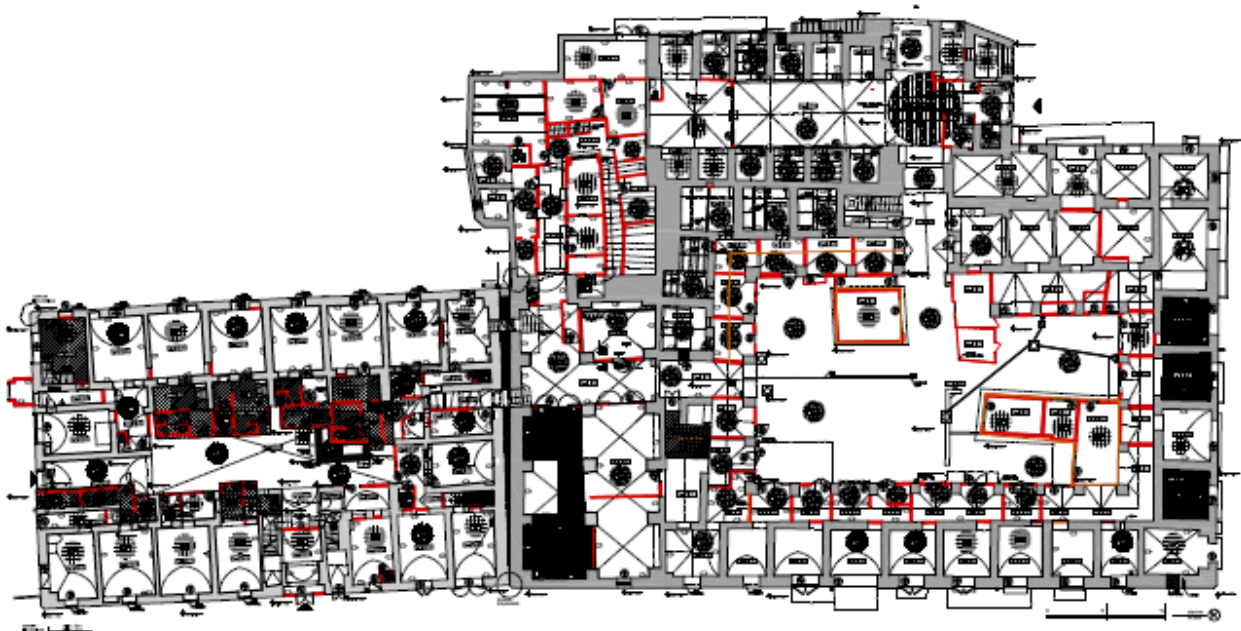
The site was cleaned from all sorts of debris, all concrete additions and partitions added by the inhabitants during 55years.

The Ground floor : all modern additions were identified [red] and removed

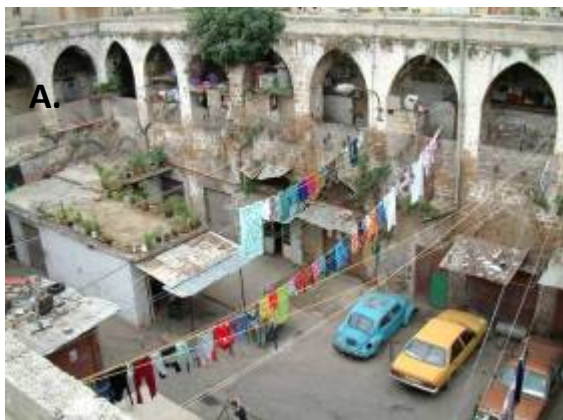
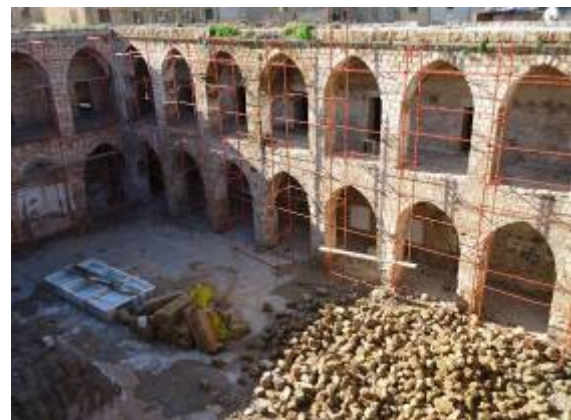
Khan A: north east interior elevation - Demolition and removal of all concrete harmful interventions

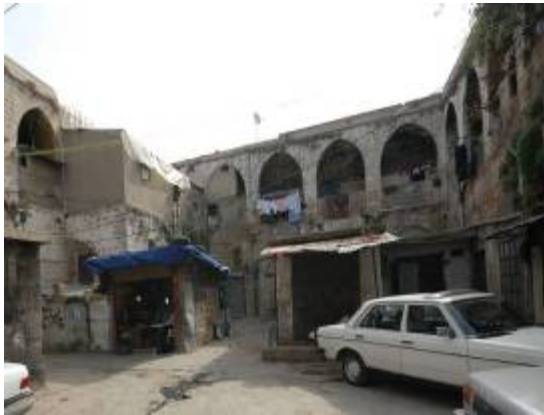
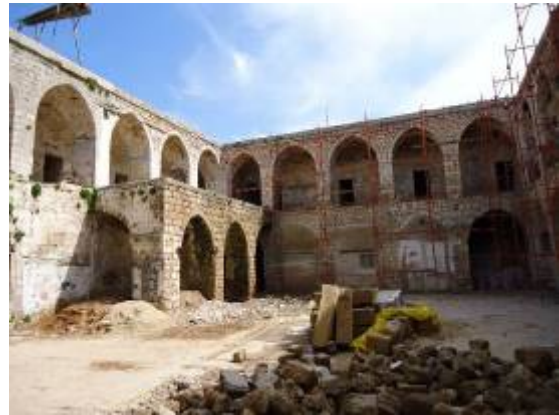
Khan A: north west interior elevation - Demolition and removal of all concrete harmful interventions

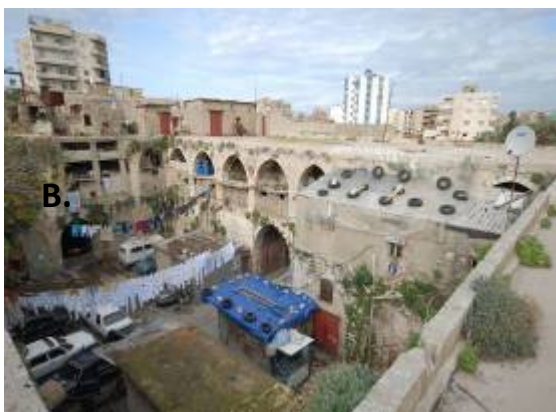
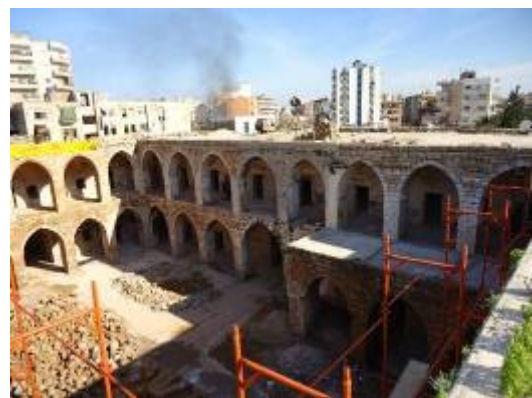
Khan A: south west interior elevation - Demolition and removal of all concrete harmful interventions

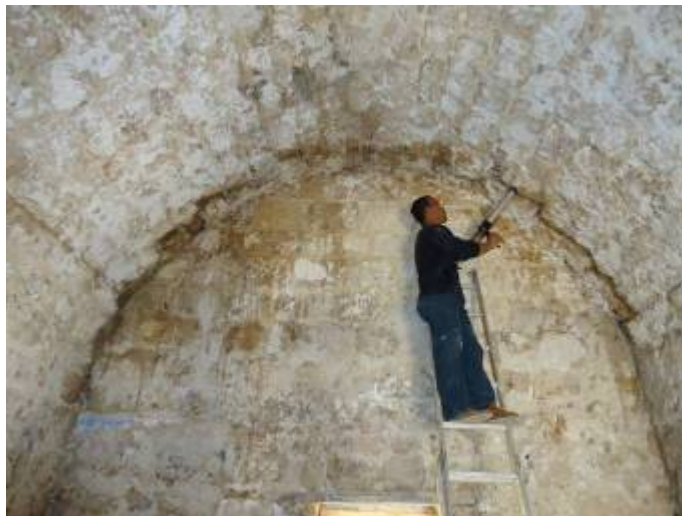
- a. All structural decays were treated: injection and grouting of all cracks

- b. The collapsed vault in the south east interior elevation – khan A was reconstructed following the traditional construction techniques

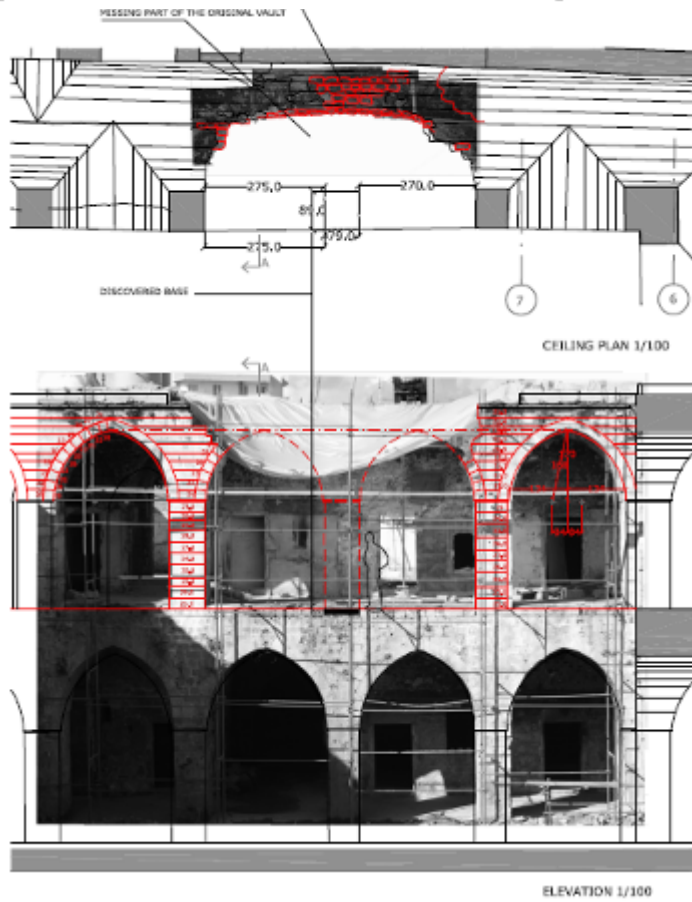
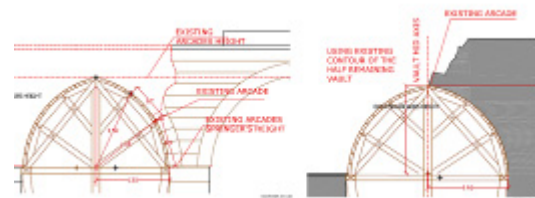
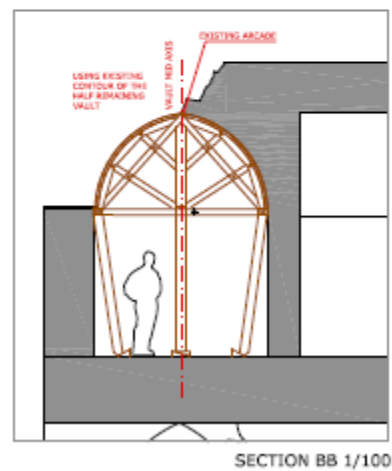
[PHASE 0: STATUS AFTER DEMOLITION]

Analysis of the material inside the vault

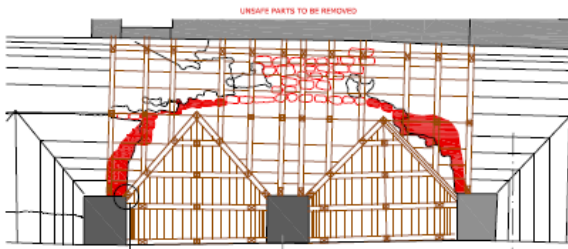
[PHASE 3: CLEANING AND REMOVAL OF UNSAFE PARTS, OF THE REMAINING PART OF THE VAULT IN ORDER TO CONNECT IT WITH THE NEW VAULT]

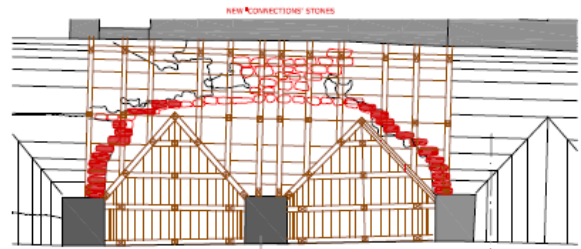
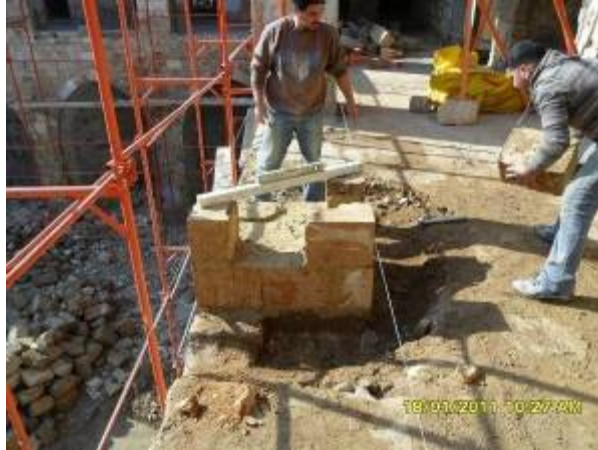
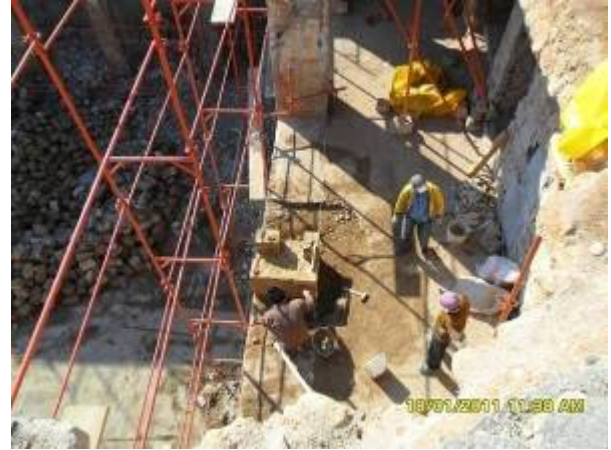
[INTRODUCTION OF NEW STONE-CONNECTORS IN THE REMAINING PART OF THE VAULT IN ORDER TO CONNECT THE EXISTING VAULT WITH NEW ONE]

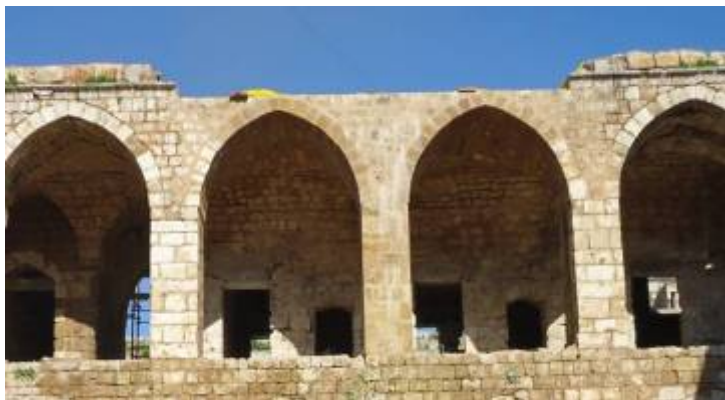
Craftsmen and workers using traditional building techniques.

And the vaults were reconstructed following the submitted approved shop drawings

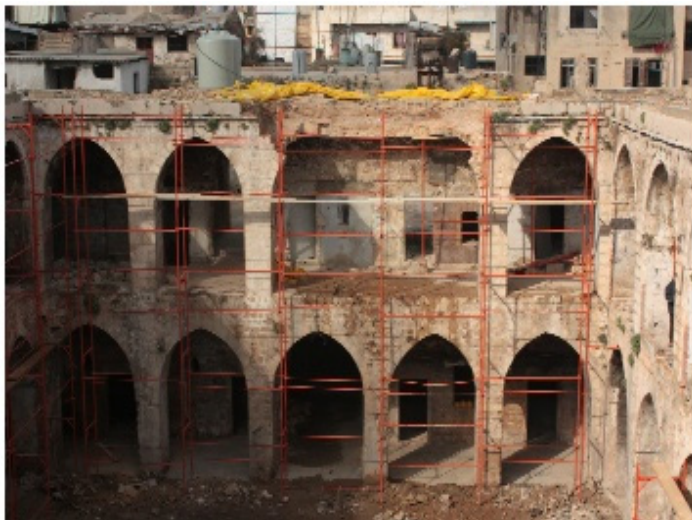
After removing the concrete structure

The interior south east façade was marked with two partially collapsed vaults that were rebuilt in traditional techniques and with the same traditional building material of the building in question (sandstone). Concrete and modern blocks were dismantled and the entire façade and the vaulting above reconstructed. Decayed stones were identified and replaced with stones of the same characteristic in order to preserve the physical and architectural coherence of the building. Hydraulic lime mortar was used in the construction of these items.

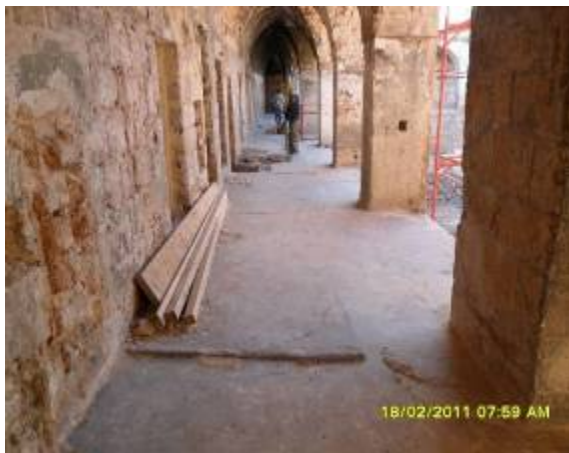
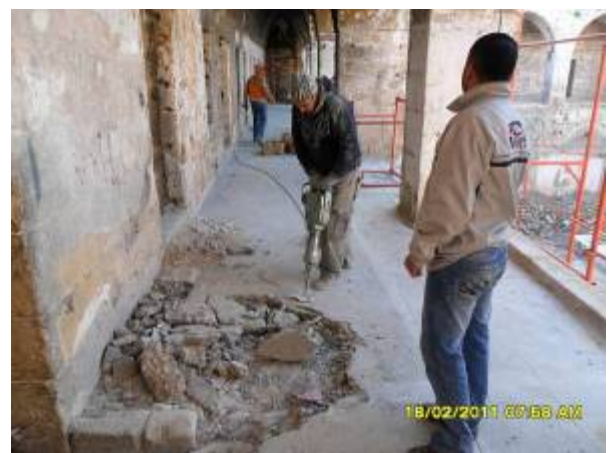
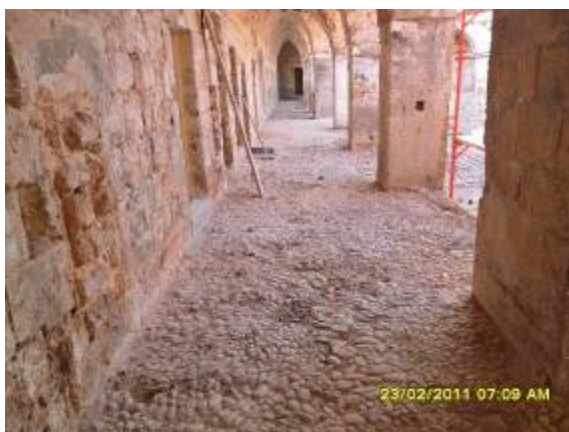
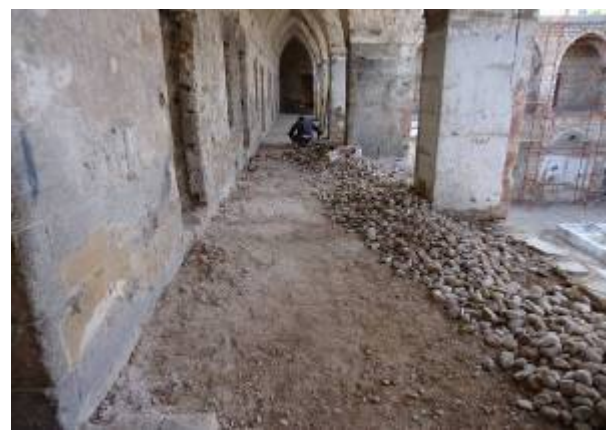
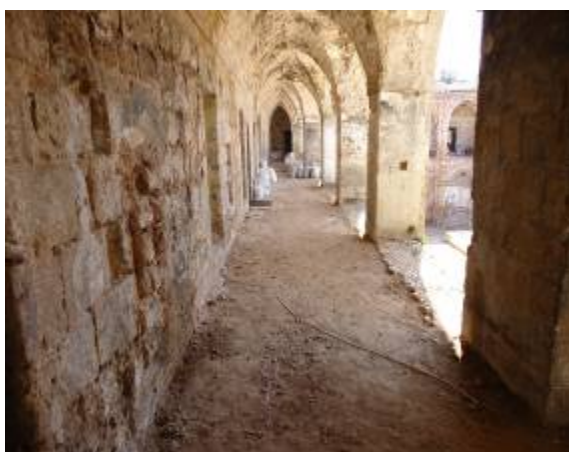
In the first floor all galleries were covered with pebbles, probably coming from Abu ali's river. A small spot of furni's stone was found in the southern corner.

- The pebbles were removed, stored, cleaned and reused in a new pattern adequate with the modern daily life; in the middle of the gallery new lime tiles were installed in a geometry following the galleries. Beneath all the mechanical and electrical installations
- The furni was documented, numbered, dismantled and re-installed after installing all mechanical and electrical installations.

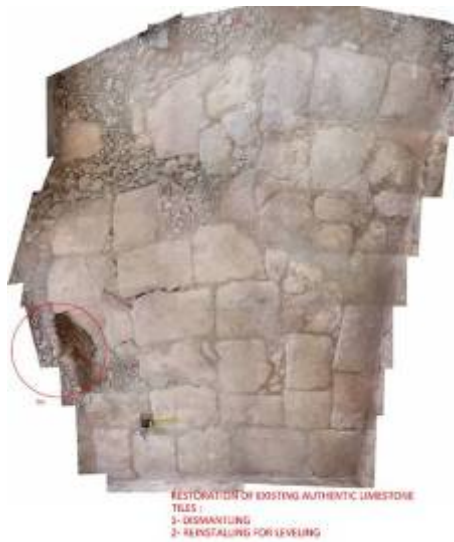
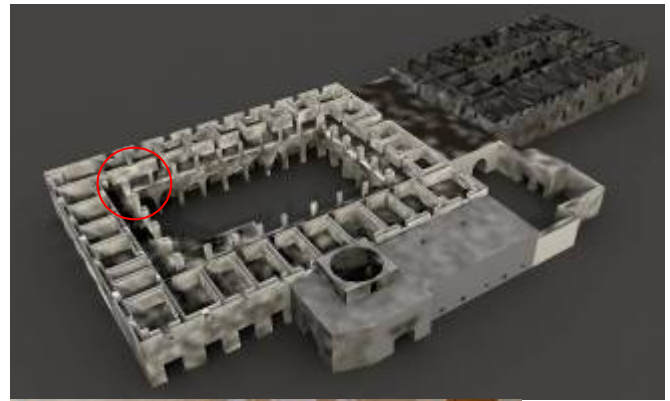
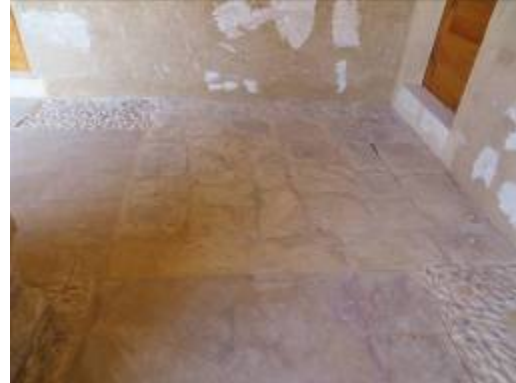
The new ottoman souk

In the **ground floor** traces of original furni tiles were found in some rooms, the vaulted stable, and the new ottoman souk.

1. 1964 picture [APSAD] where traces of original furni
2. Before removing the cement layer
3. After removing the cement

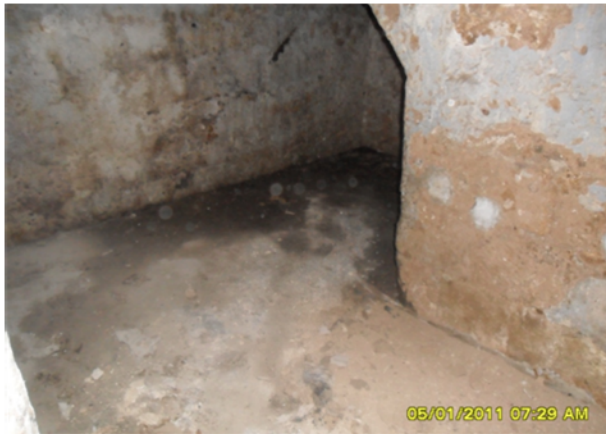
Before Concrete slabs Demolition Block A- Ground Floor, Room 129

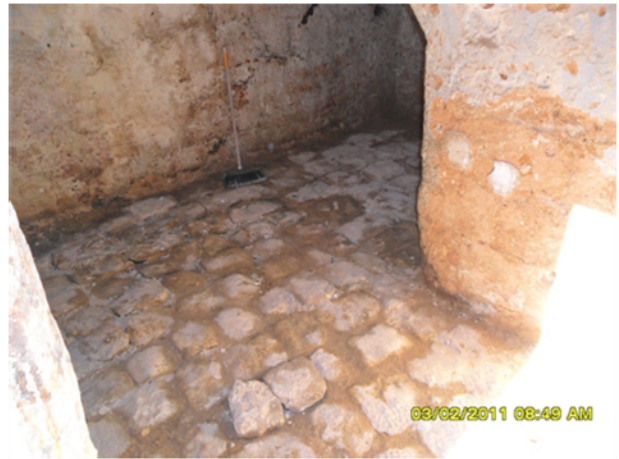
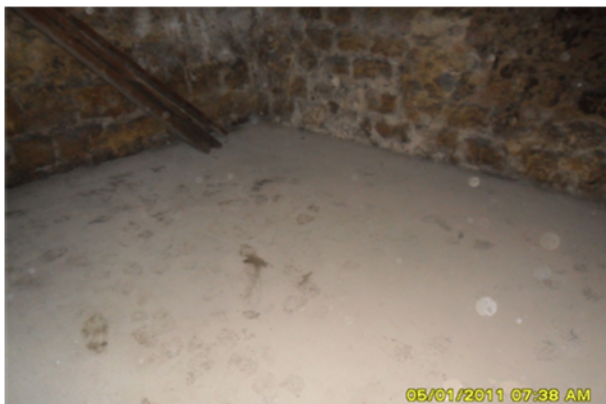
Before Concrete slabs Demolition Block A- Ground Floor, Room 114

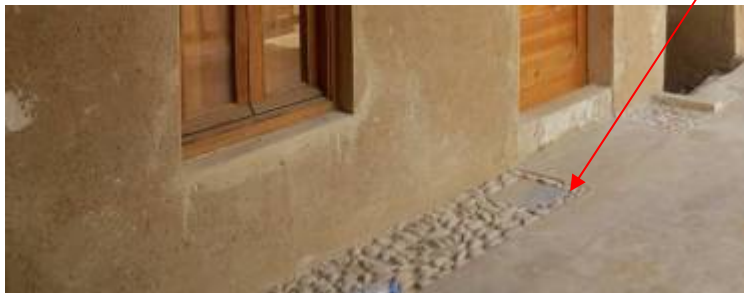
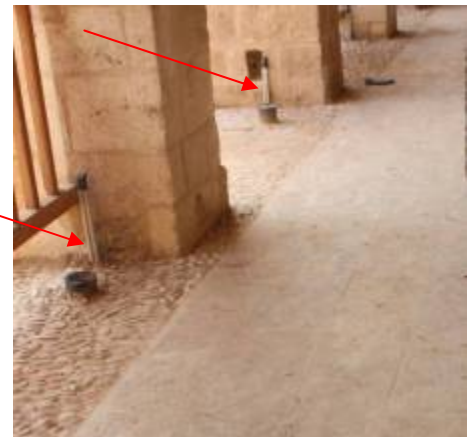
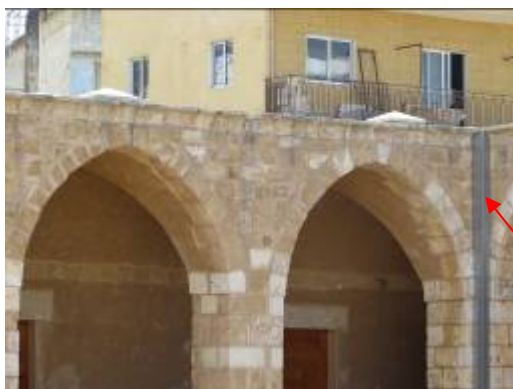
electrical works consisted of installing all pipes and conducts ready to receive the wires whenever the khan is occupied. As for the sanitary, the installation of all necessary piping and accessories was executed.

Rain water was drained on the interior facade angles.

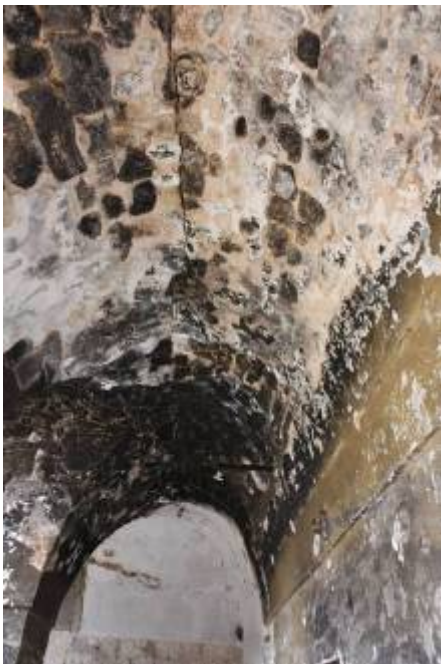
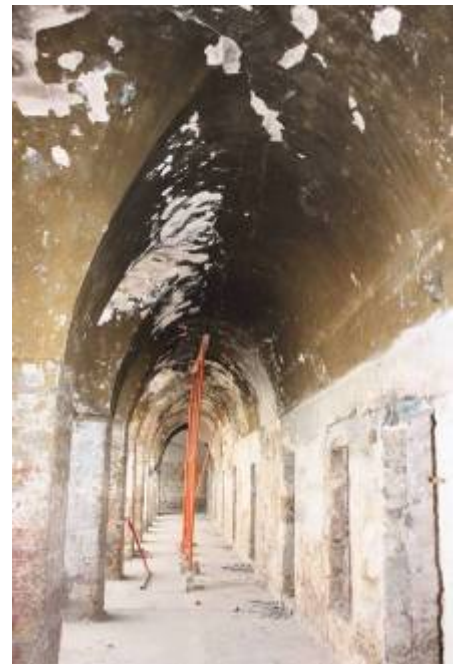
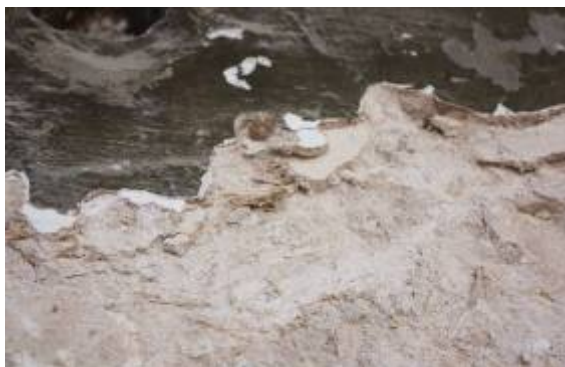
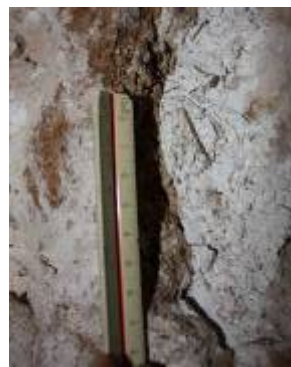
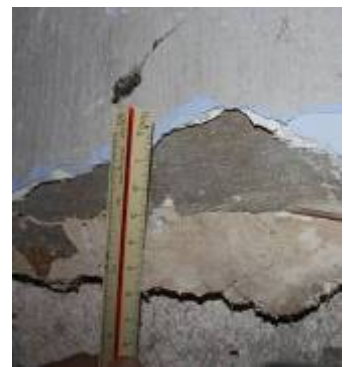
All the original plaster was removed because of its advanced decayed state.

1. 2 Original plaster status

3.4.5 Original plaster analysis

Removing the old decayed plaster without altering the masonry. Cleaning the joints and surfaces to insure a better adherence with the plaster. The first layer of adherence is around 5cm thick dosed 400 to 450 kg of hydraulic natural lime for each one cubic meter of sand, when dry, a second smoother layer is applied to insure specifications of insulation, 300 to 350 kg of hydraulic natural lime for each one cubic meter of sand 15 to 20 mm thick. The finishing layer is dosed of 250 to 300kg of hydraulic natural lime for each one cubic meter of sand, with a thickness of maximum 7mm. Humidifying and drying each layer of plaster takes around three days.

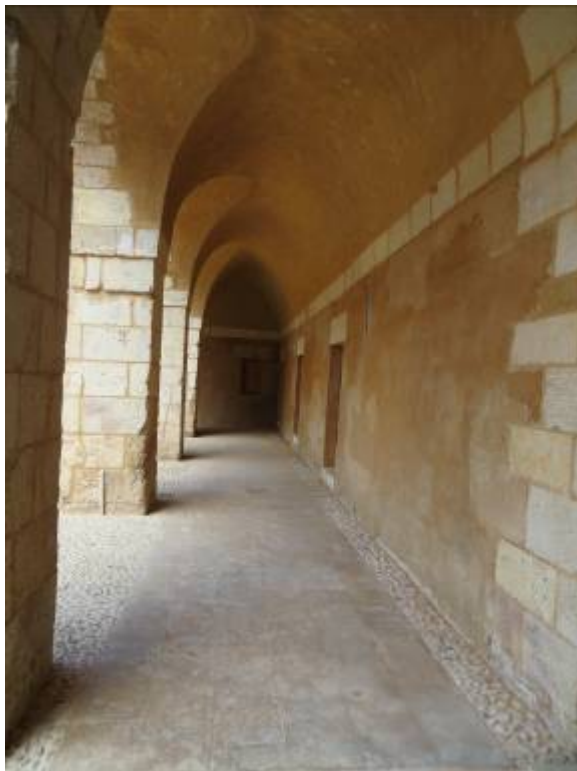
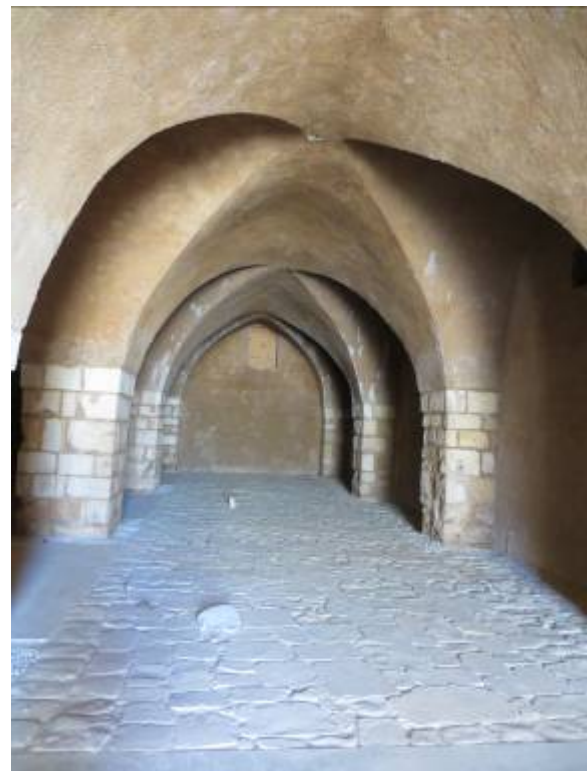
1. New lime plaster application
2. Laboratories analysis of the Original plaster components

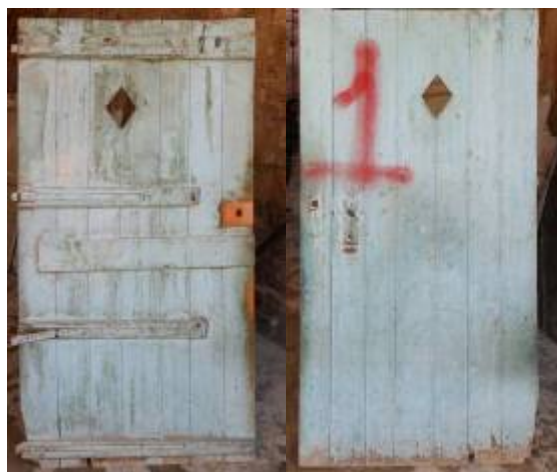
A similar door with few modification to provide better insulation was designed.

DOOR DR1 - PROPOSED ACCESSORIES
DETAIL D1. METAL RING 1/2

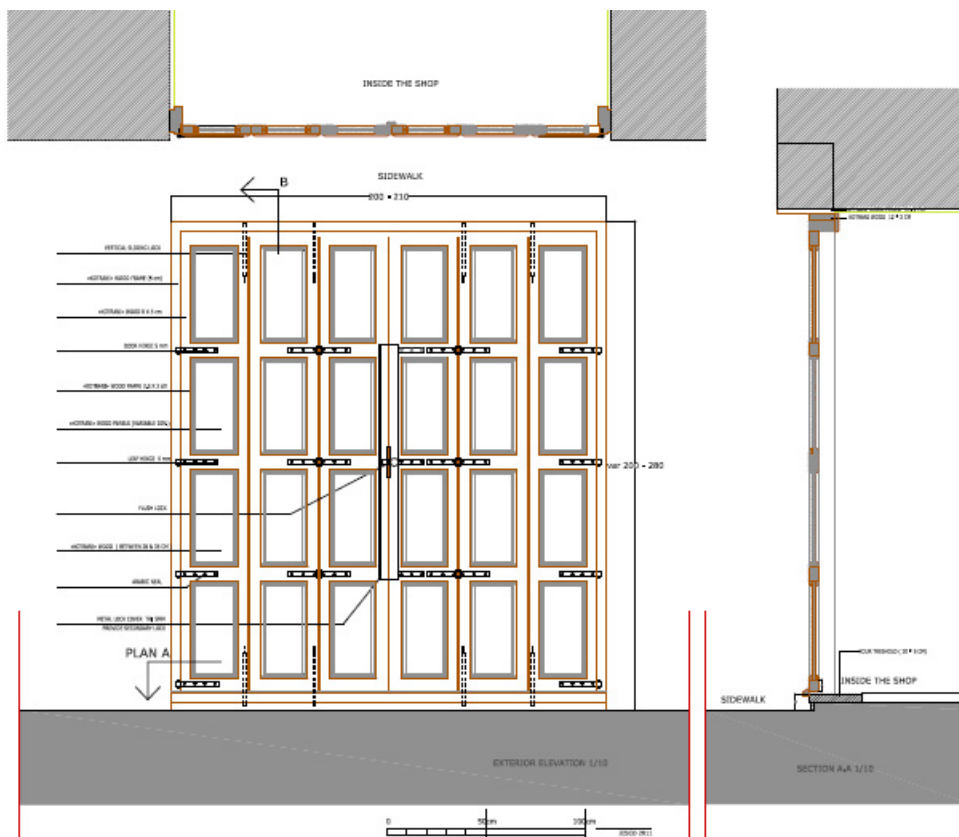
Shops doors

The shops kept their doors giving to the outside instead of the courtyard. The traditional shop door found in traditional souks in Tripoli and Saida was adapted.

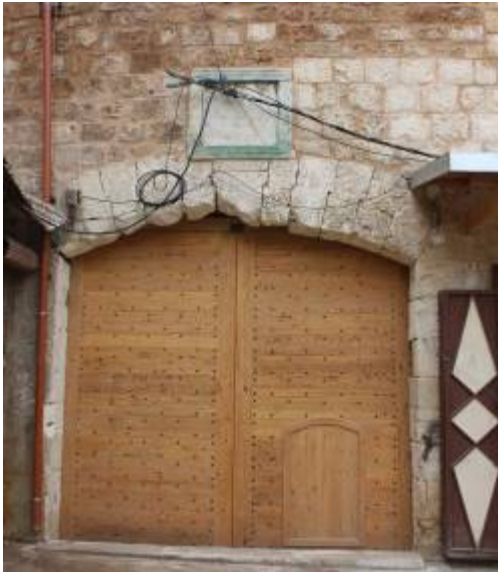
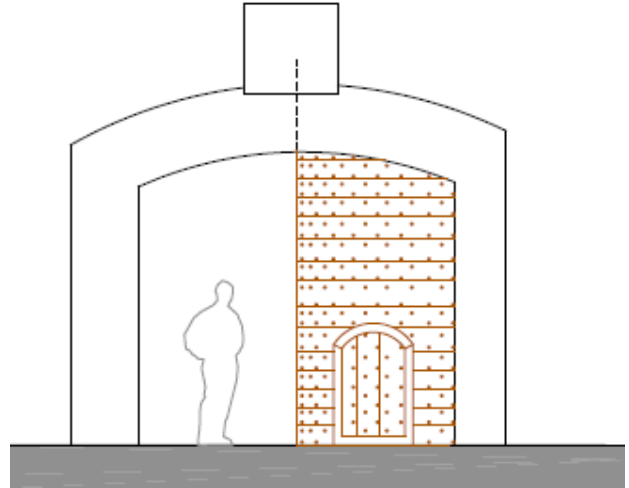
The main gates

The traditional khan's door found in traditional khans in Tripoli and Saida was adapted.

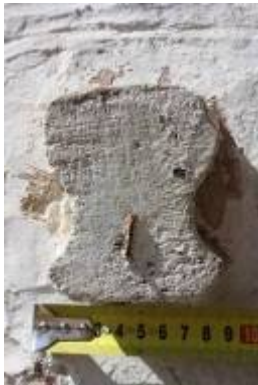
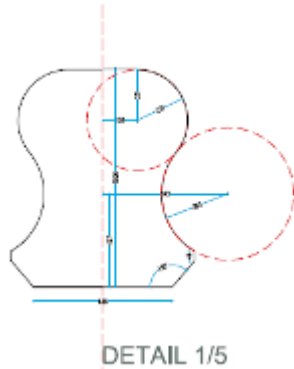
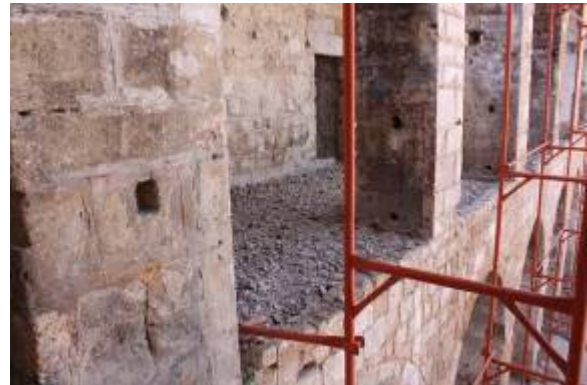
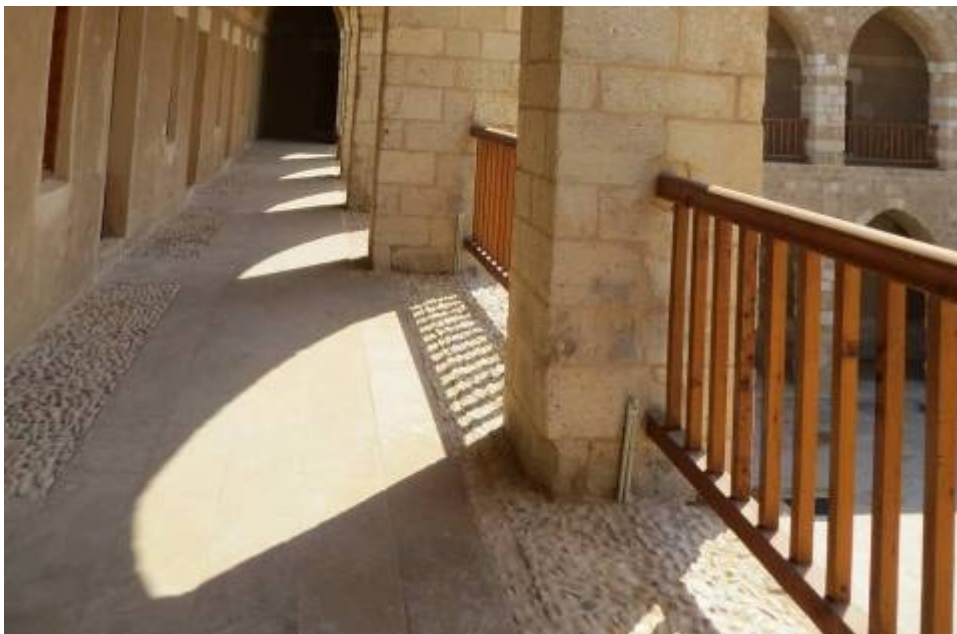
The handrail

Traces of the original wooden kotrani handrail were found in their original location. After being surveyed and copied, the same shape was proposed and executed. Additional horizontal bars were added for security reasons. They were inspired from balustrades in Syrian khans .

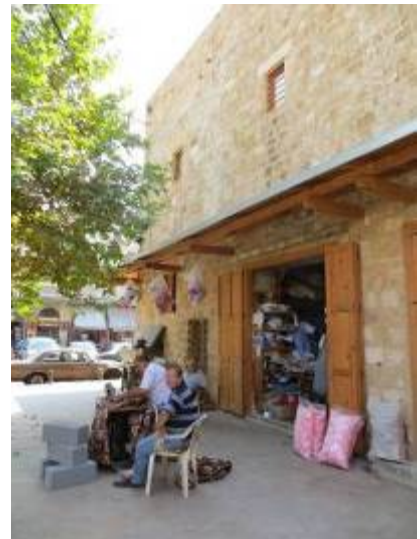
the proposed shamsiyyat are a simplified copy from the ones belonging to the 1900 period.

The canopies were made as a very simplified, light wooden structure inspired by historical models and techniques.

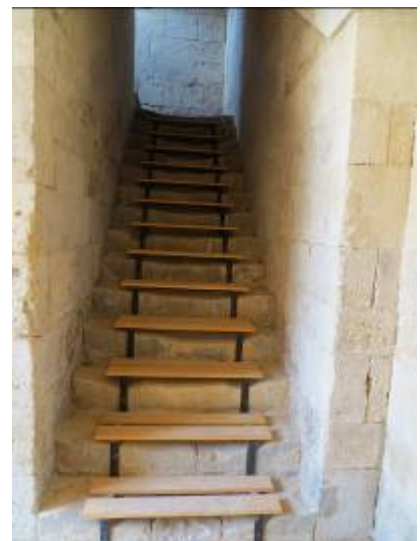
Stairs

In order to protect the original steps and at the same time to allow a secure use of the stair, new wooden steps installed on metallic structure were designed and executed.

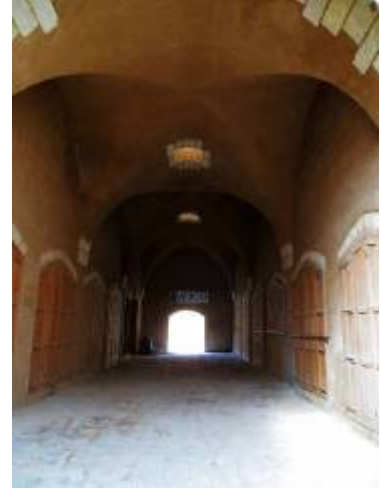
Souk Skylights

All the skylights in the new ottoman souk were closed with concrete for protection against water. In order to retrieve the original character of the space as it was conceived by the builders and to meet today’s needs, these skylights were covered with glass to protect from rain but letting in the day light and air for ventilation.

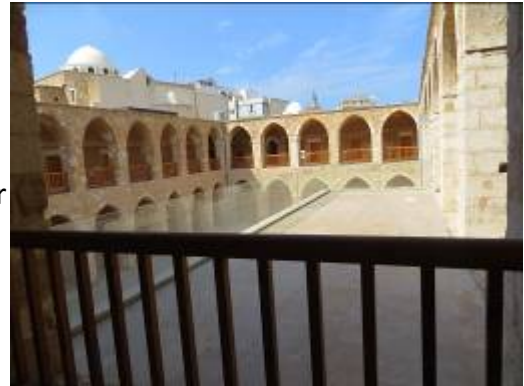
fig1. The handrail installed on the part that was added during the ottoman times was designed in glass in order to allow the reading of the addition and the original continuity of the courtyard.

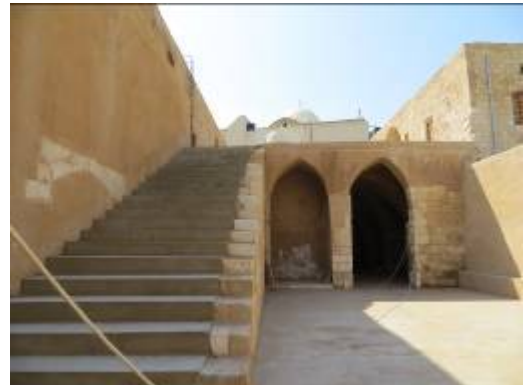
Fig2. The stair added during the mandate was partially demolished by the inhabitants.

It was decided to cover it with cement and epoxy in order to distinguish it from the original structure

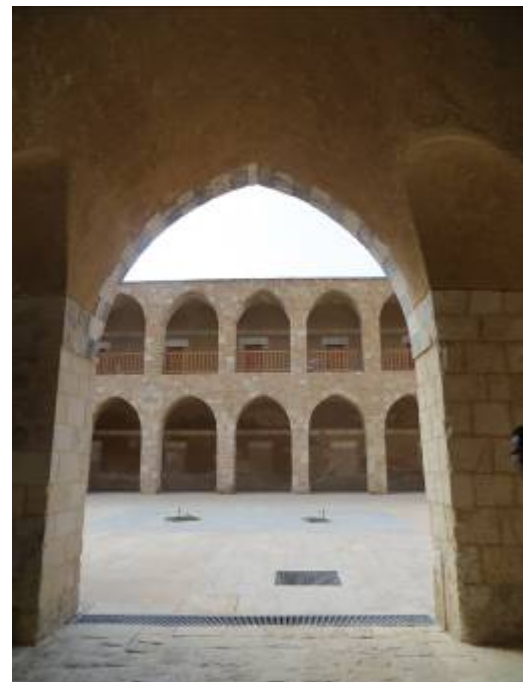
Fig3. The basalt tiling in the middle of the courtyard
It retraces the limits of the fountain as defined in the old cadastre without building it .
